Fine Tuning

Fine tuning can be done at three points.

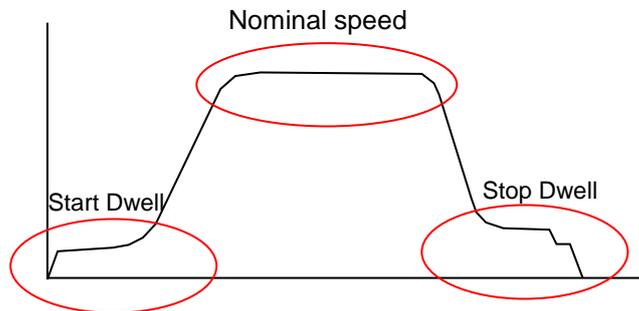
1) START UP: As motor starts running at first the lift moves suddenly up then accelerates smoothly

Reason: P3-07 (leakage frequency) set too high

Do! Set leakage frequency (P3-07) correctly

- Note down set values of P6-01 and P6-02 from programming menu.
- Set P6-01 to 0.0Hz and P6-02 to 12.0s.
- Run the lift **EMPTY** in up direction at nominal speed. Lift will stay at floor standing or move slowly for 12 seconds and then will start to travel.

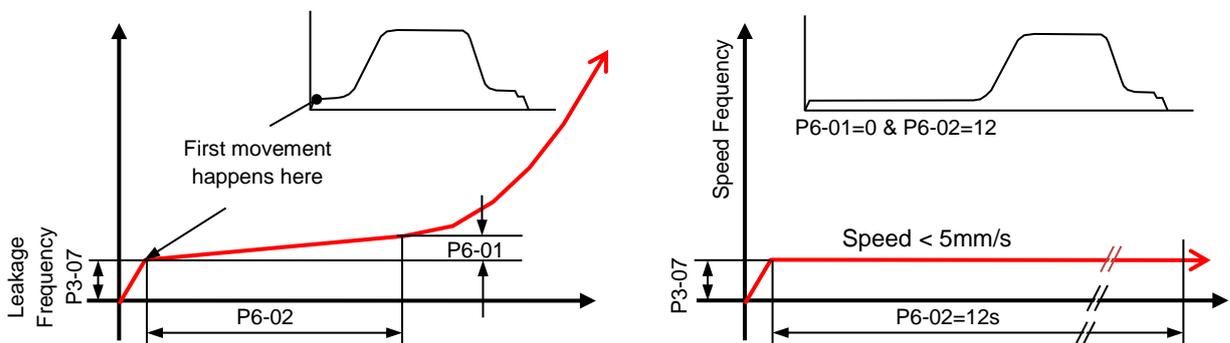
d) Adjust P3-07 (leakage frequency) so that lift moves upwards (EMPTY) very slowly about 5mm/s (=0.005m/s) or less during the initial 12s.

How? Give nominal speed signal to run the lift upwards empty. Observe the lift movement for the first 10 seconds. After 10 seconds cancel the up run (not to allow the lift to have a full travel):

- If lift stays at the floor standstill then increase **P3-07** by 20% at a time until lift starts moving at very slow speed (**<5mm/s =0.005m/s**).
- If lift moves at a speed above **5mm/s** then reduce **P3-07** by 20% at a time until speed is lower than **5mm/s**.
- Note down the frequency at which the lift moves about **5mm/s** (e.g. 2.50Hz). Reduce 0.30Hz from the value and set it to P3-07 (e.g. P3-07 =2.50 – 0.30 = 2.20Hz).

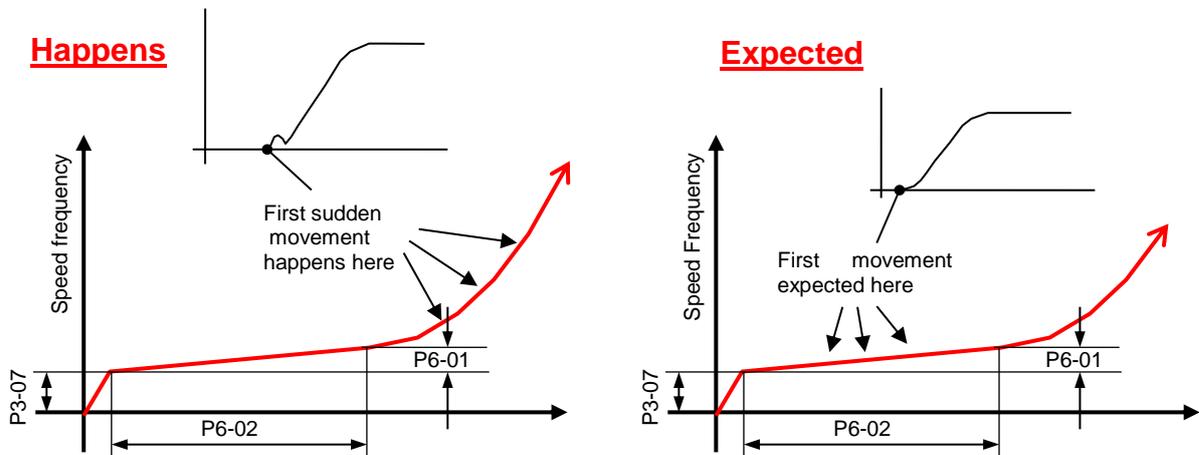
2) START UP: After motor starts the car stays at the floor for a while (3 to 10 second) and moves up with a jerk

Reason: P3-07 (leakage frequency) set too low and therefore take off happens during acceleration stage. It should take place during start dwell.

Do! Determine leakage frequency correctly (See item 1, in start up above)

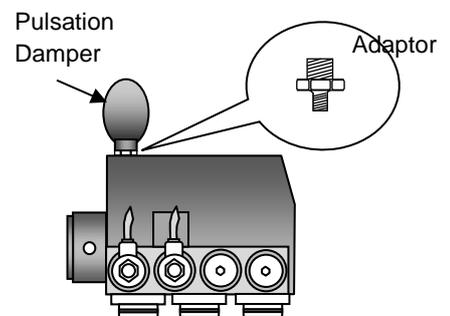
Reason 2: Low motor or/and pump performance

Do! Connect the pulsation damper at the EV4 valve (Use Z1 port at the back of the valve)

Make sure that pre-fill pressure of the pulsation damper is:-

$P_{pre-fill} = 0.6 \text{ to } 0.7 \times \text{Empty car pressure.}$

How? Close the ball valve → Turn emergency lowering to relieve the pressure → Remove the plug from the **Z1** port → Connect the pulsation damper to the EV4 valve by using ¼" to ½" adaptor with copper washers.

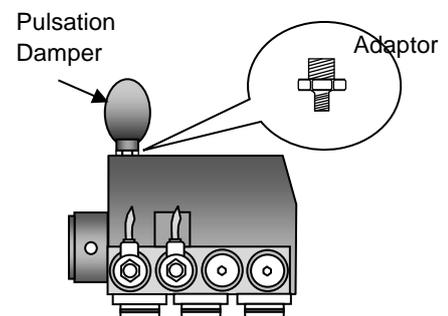
Do! Connect the pulsation damper at the EV4 valve (Use Z1 port at the back of the valve)

Make sure that pre-fill pressure of the pulsation damper is:-

$P_{\text{pre-fill}} = 0.6 \text{ to } 0.7 \times \text{Empty car pressure.}$

How? Close the ball valve → Turn emergency lowering to relieve the pressure → Remove the plug from the **Z1** port → Connect the pulsation damper to the valve by using 1/4" to 1/2" adaptor with copper washers.

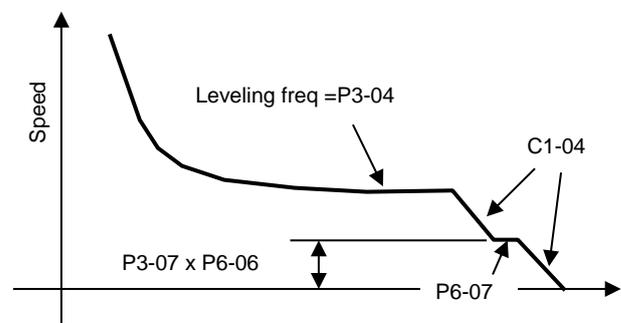
7) SOFT STOP: the car overshoots the floor level

Reason: Stop dwell parameters set incorrectly

- Decrease **C1-04** by 0.2s at a time
- Decrease **P6-06** by 0.1 unit at a time
- Decrease **P6-07** by 0.1s at a time
